# Assessment and Strategy Development

May 21<sup>st</sup>, 2008

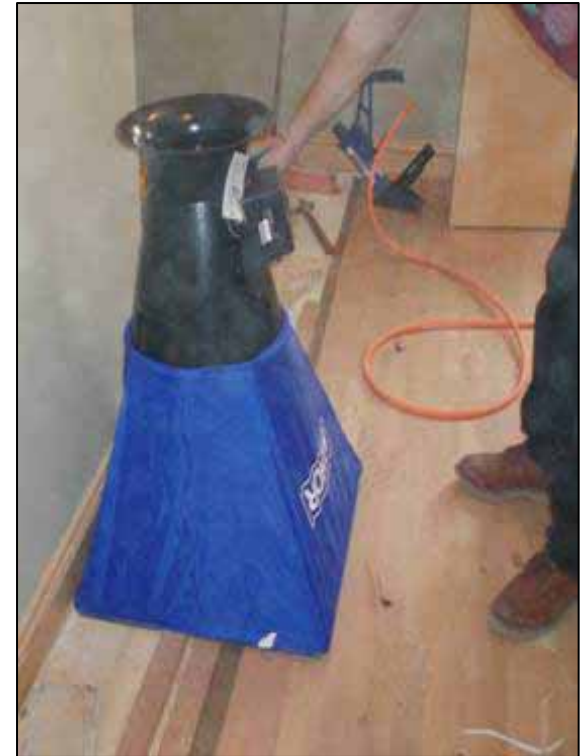
# Understanding Testing

- The blometer test
  - Measuring cfm of exhaust
  - Impact on durability to remove moisture
  - Get what you paid for
  - Causes: Kinks, obstructions, faulty motors, to much restriction

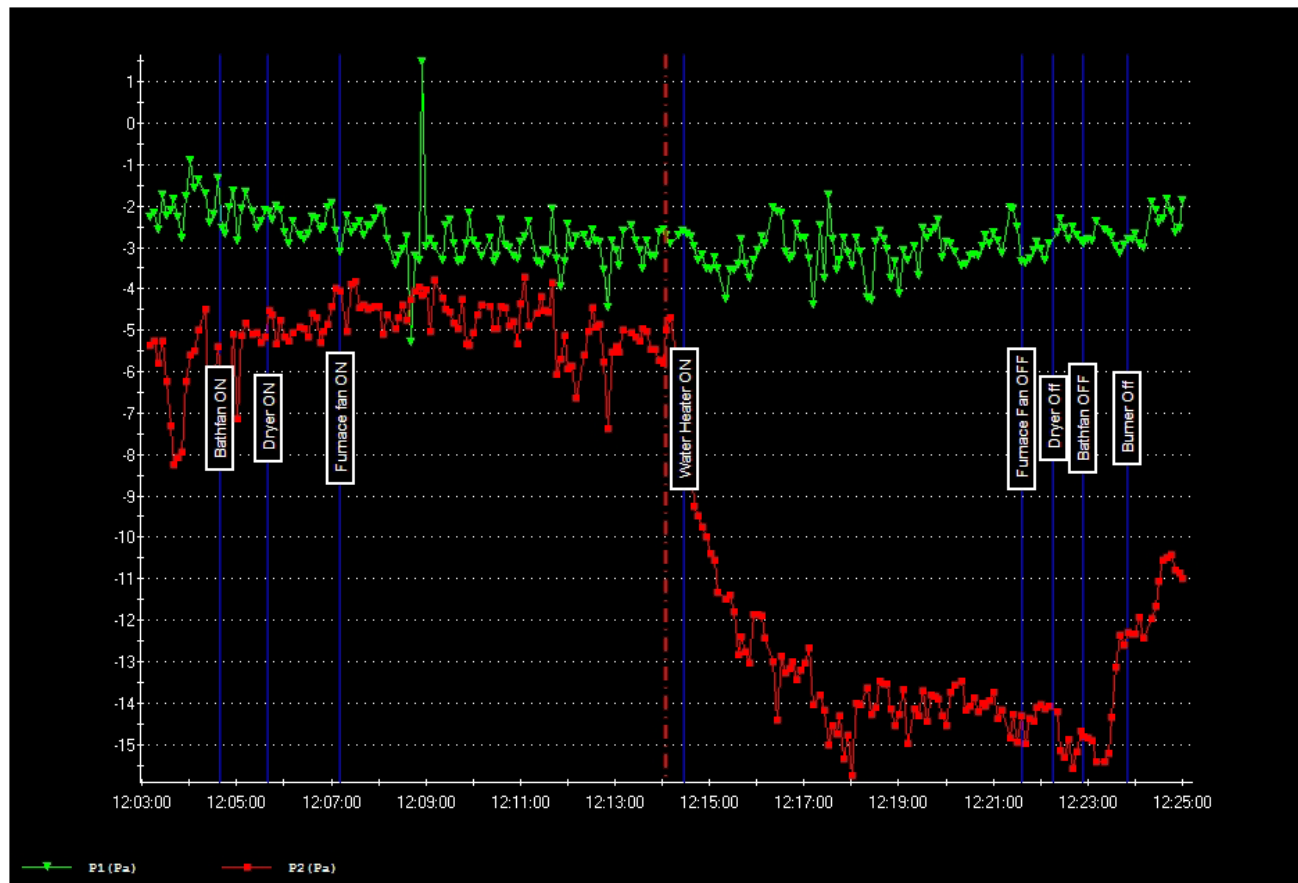
# Spillage Test results

# Combustion Spillage

- How is it tested
  - Creating a worst case scenario with exhaust devices
  - Measuring the flow of flue gas before during and during worst-case event
    - Flow of flu-gas must remain positive throughout the test
    - Levels lower than 2 pascals suggest a risk for backdrafting
